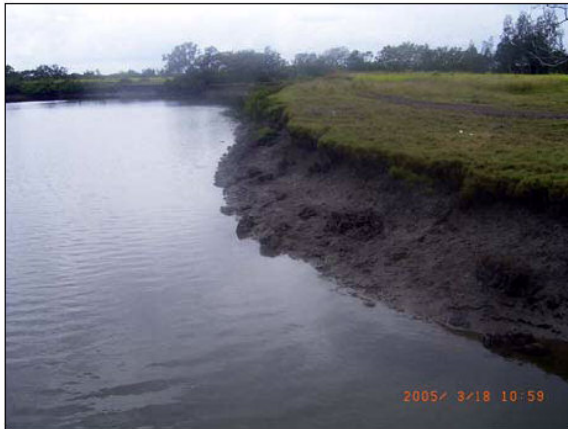
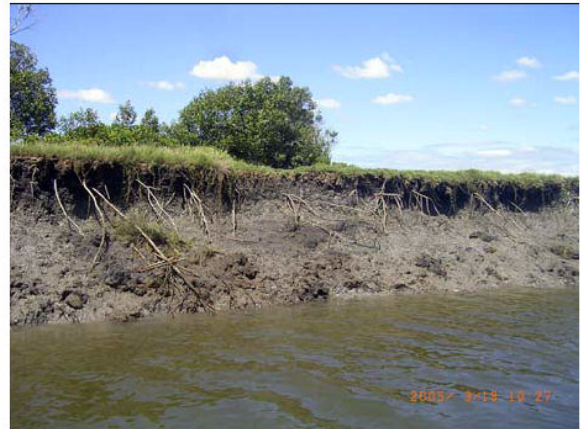
a.

Plate 6. Erosion issues, Caboolture River: a & b) bare river banks with erosion evident in intertidal zone; c) mature mangroves overhanging river; d) pneumatophores (peg roots) of mangroves stabilising the shoreline; e) onsite erosion from unauthorised vehicles; f) car dumped in the Caboolture River on project site upstream of entrance to proposed marina basin.
