Lensworth Group Pty Ltd

Information Request Response

Caboolture Waters: Waterways, Soils and Water Quality Management

13 August 2004

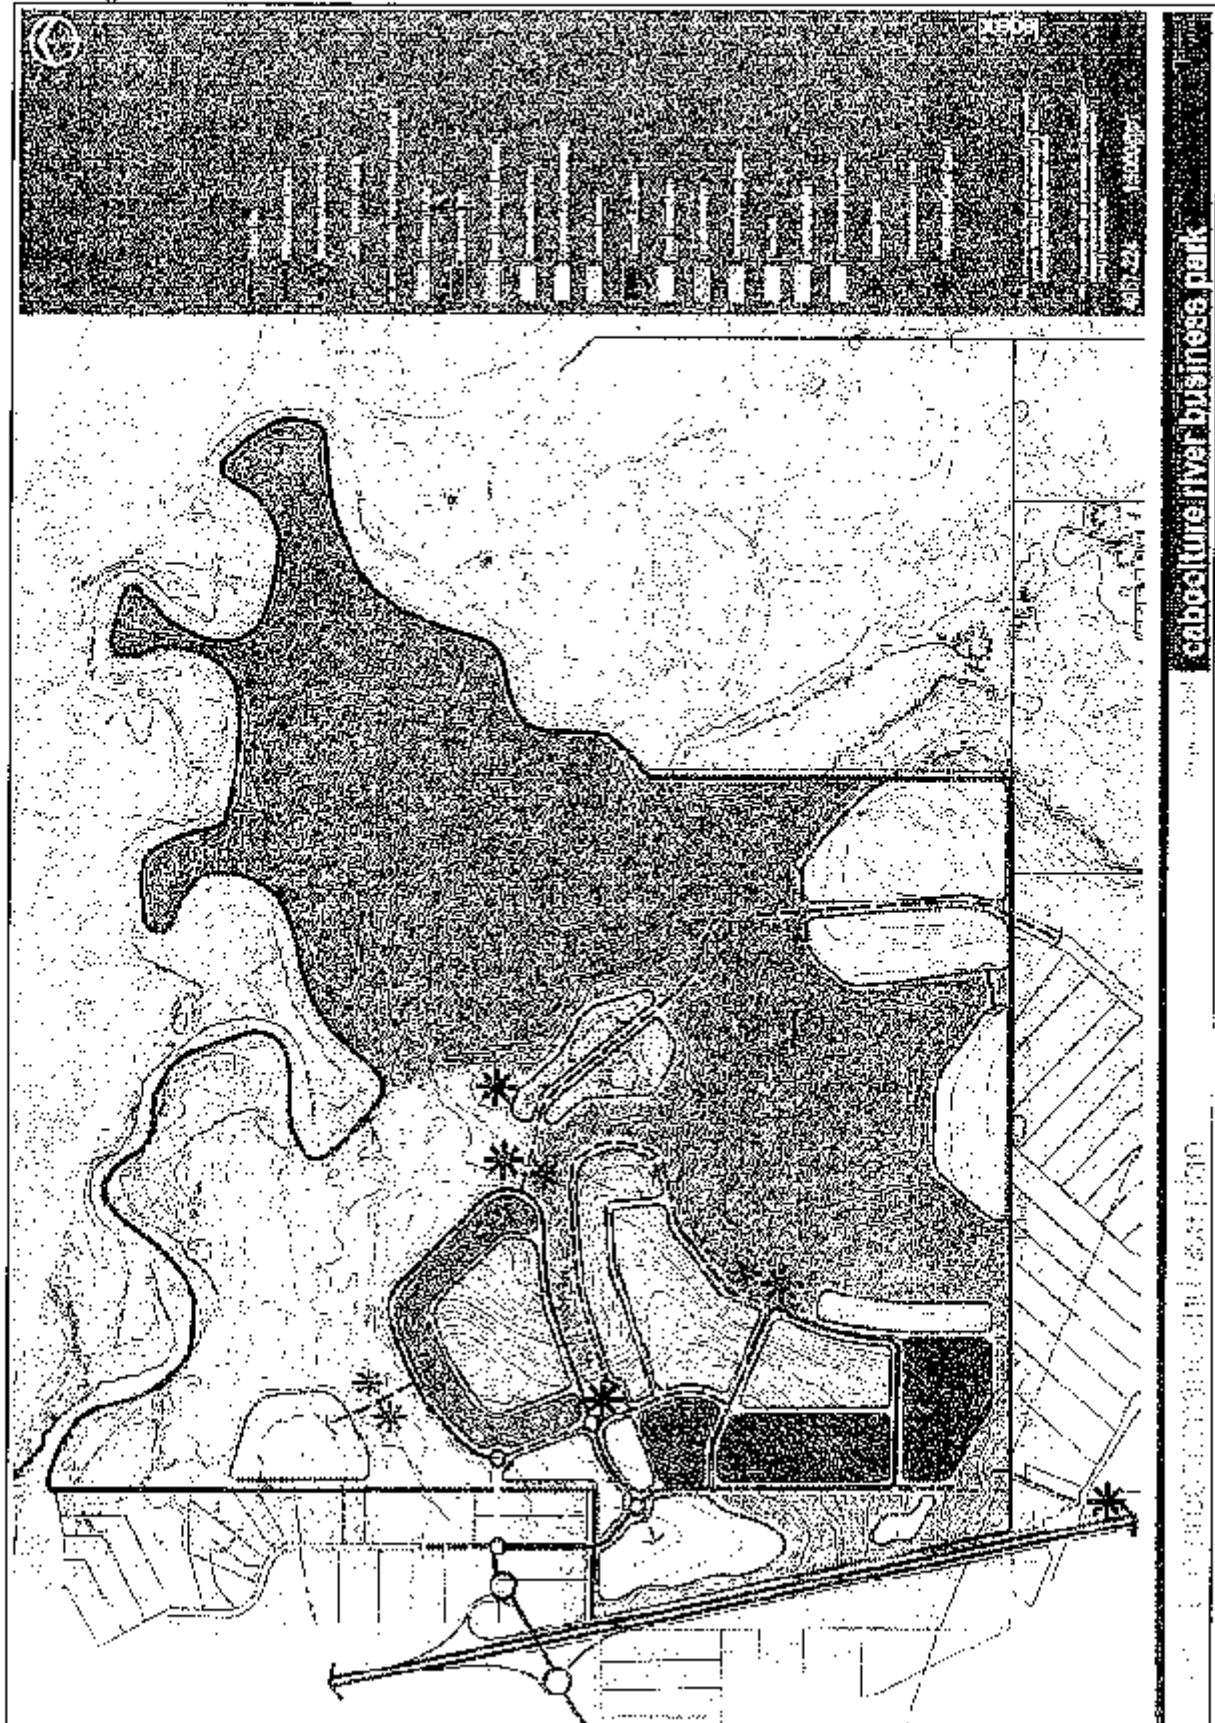
Figure 4.1: Indicative Structure Plan

The preliminary calculations undertaken by Parsons Brinkerhoff identify that there is sufficient material available on site to meet filling requirements for staged development of the site (to achieve development above the Q100 line), in keeping with Council's requirement for balanced cut and fill within the floodplain.

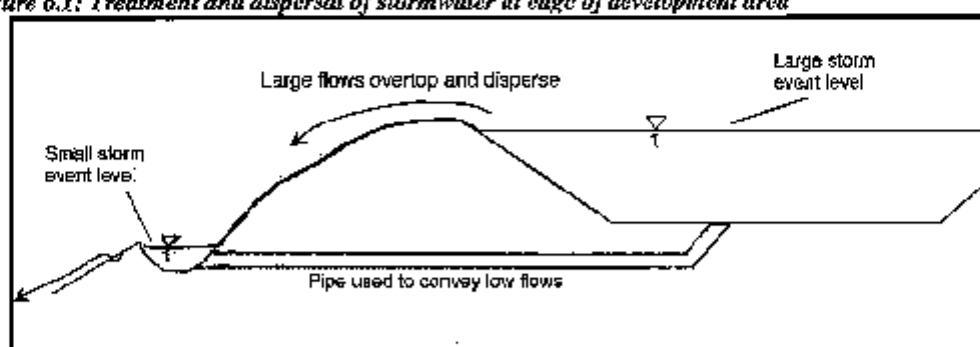
Figure 6.1: Treatment and dispersal of stormwater at edge of development area

Stormwater in smaller events would be captured initially in the upper drain, and be conveyed via the pipe to a shallow spoon drain just below the top of the fill batter, where it would overtop the drain to disperse via sheetflow or natural evaporation. In larger storm events, water would be captured in the upper drain faster than it could flow through the pipe system. As the drain filled, water will overtop the top of bank, and flow down the batters and into the natural waterways and flow paths of the flood plain (Figure 6.1).

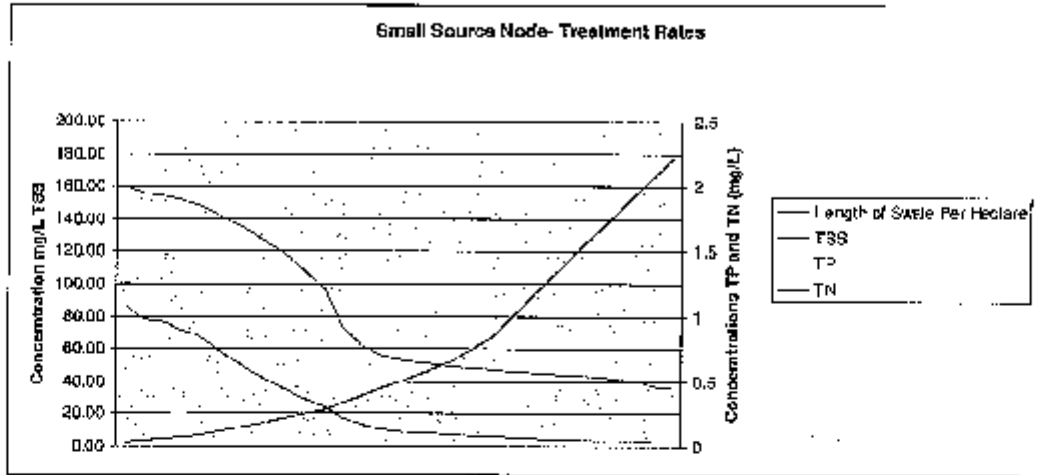
Figure 6.2: Small Area Treatment Efficiencies

The first stormwater treatment option involves the use of bio-filtration/swale system along roads, parkland and other open spaces. This system was modelled upon a standard Type 1 swale as per the *Water Sensitive Road Design Guidelines*, produced by Brisbane City Council, June 2003. The two areas modelled were set at 103 hectares and 4.5 hectares, based on preliminary estimates of the proposed developable areas. The swale size and storage properties were modelled with increasing areas and the treatment efficacies recorded. Due to the large number of low flow conditions, a flow based sub-sample was used to help make the statistics more realistic. The results of the small and large source nodes are shown in Figures 6.2 and 6.3.

As illustrated in the graphs above, the concentrations of TSS, TP and TN decrease in proportion to increases in the biofiltration area. From analysis of the raw data it was determined that for the small source node, just over 800m of swale/biofiltration is required in order to meet the WQOs for the site. Table 6.4 shows the areas of bio filtration that are required to meet each WQO.
